# Flight Motor Set 360L008 (STS-32R) Final Report

## Volume I - System Overview

Flight Motor Set  
360L008 (STS-32R)  
Final Report

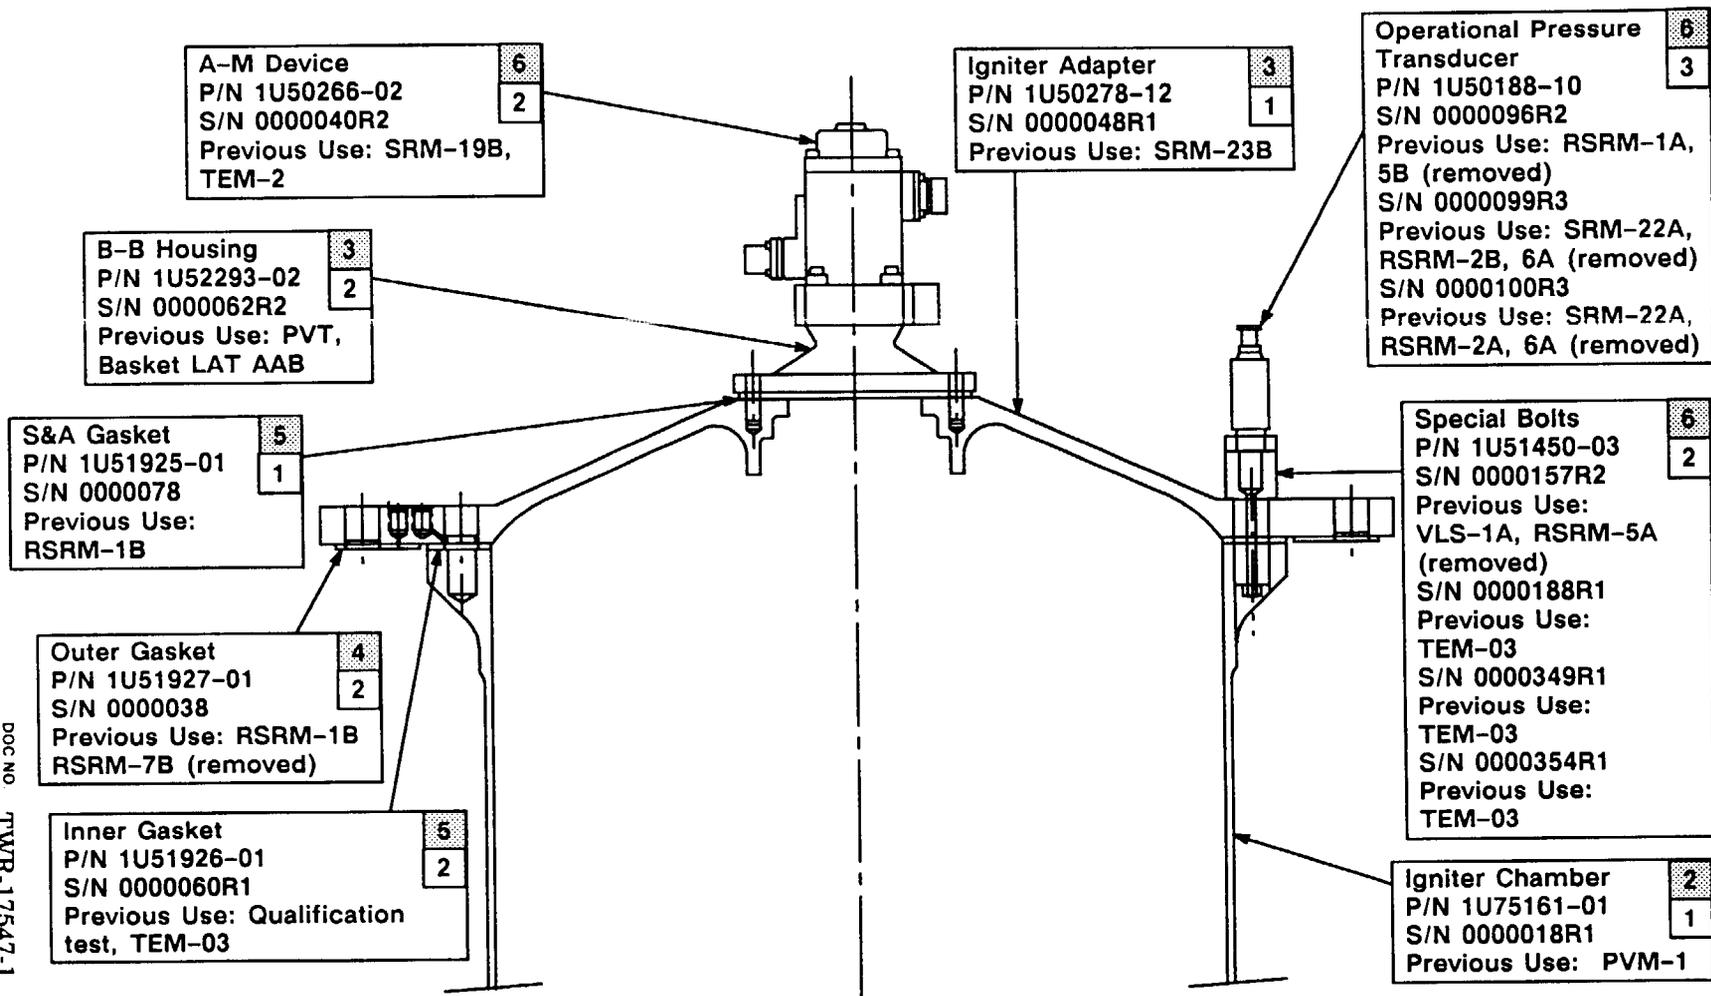
Figure 4.2-4. Hardware Reuse Summary—RH (B) Igniter

Conclusion: P/N 1U52842-01, S/N 0000006R3 is an inventory leader

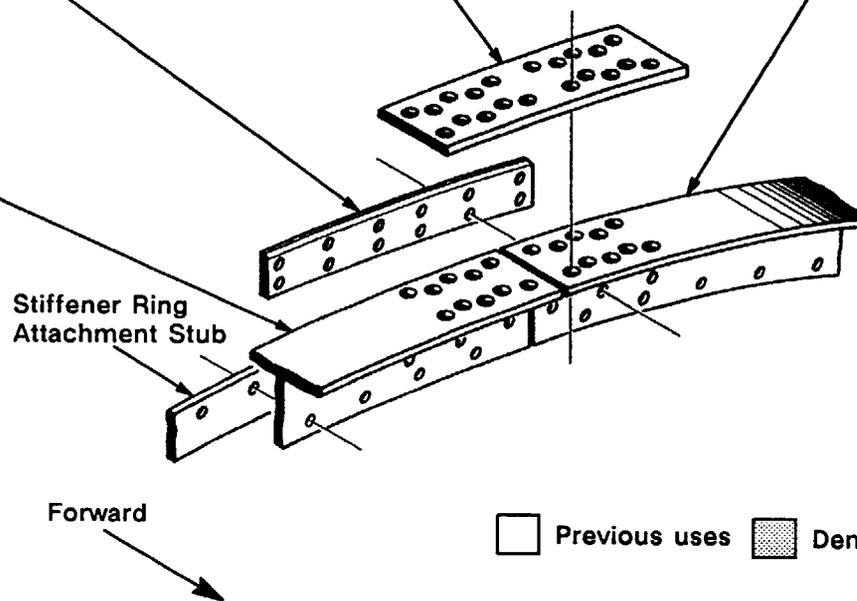
**Figure 4.2-7. Hardware Reuse Summary—LH (A) Stiffener Rings at Normal Joints**

**Conclusion:** There are two inventory leader components in this assembly

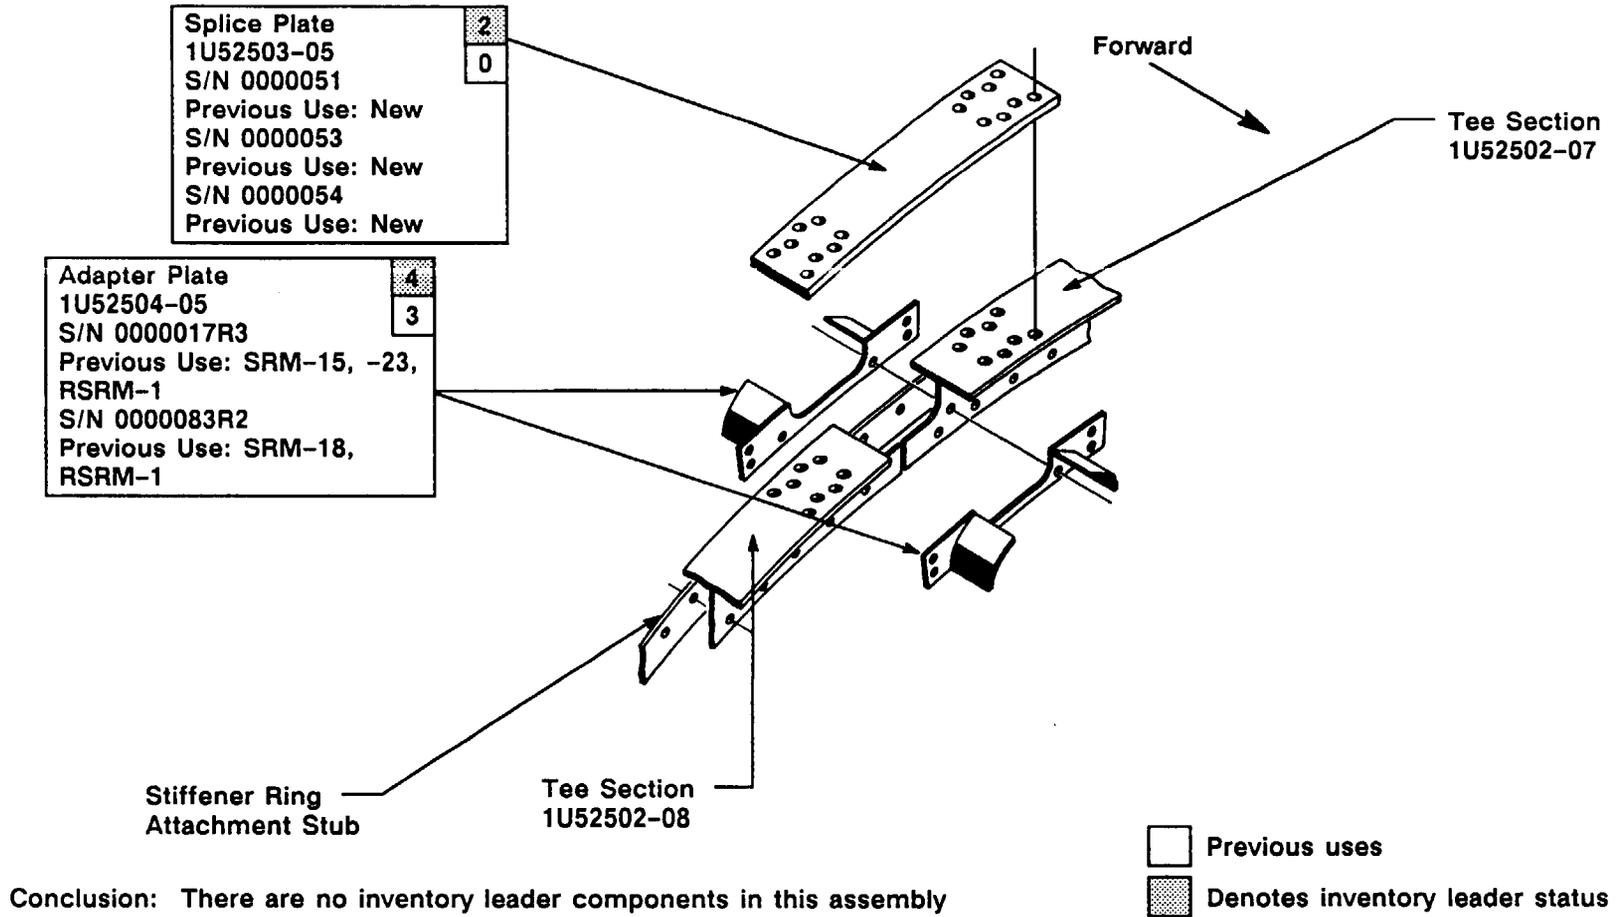
Figure 4.2-10. Hardware Reuse Summary—RH (B) Stiffener Rings at Systems Tunnel Joint

need to file out the attach slot due to tolerance buildup at the forward bridge splice plate (interface of systems tunnel and forward skirt/SRM)

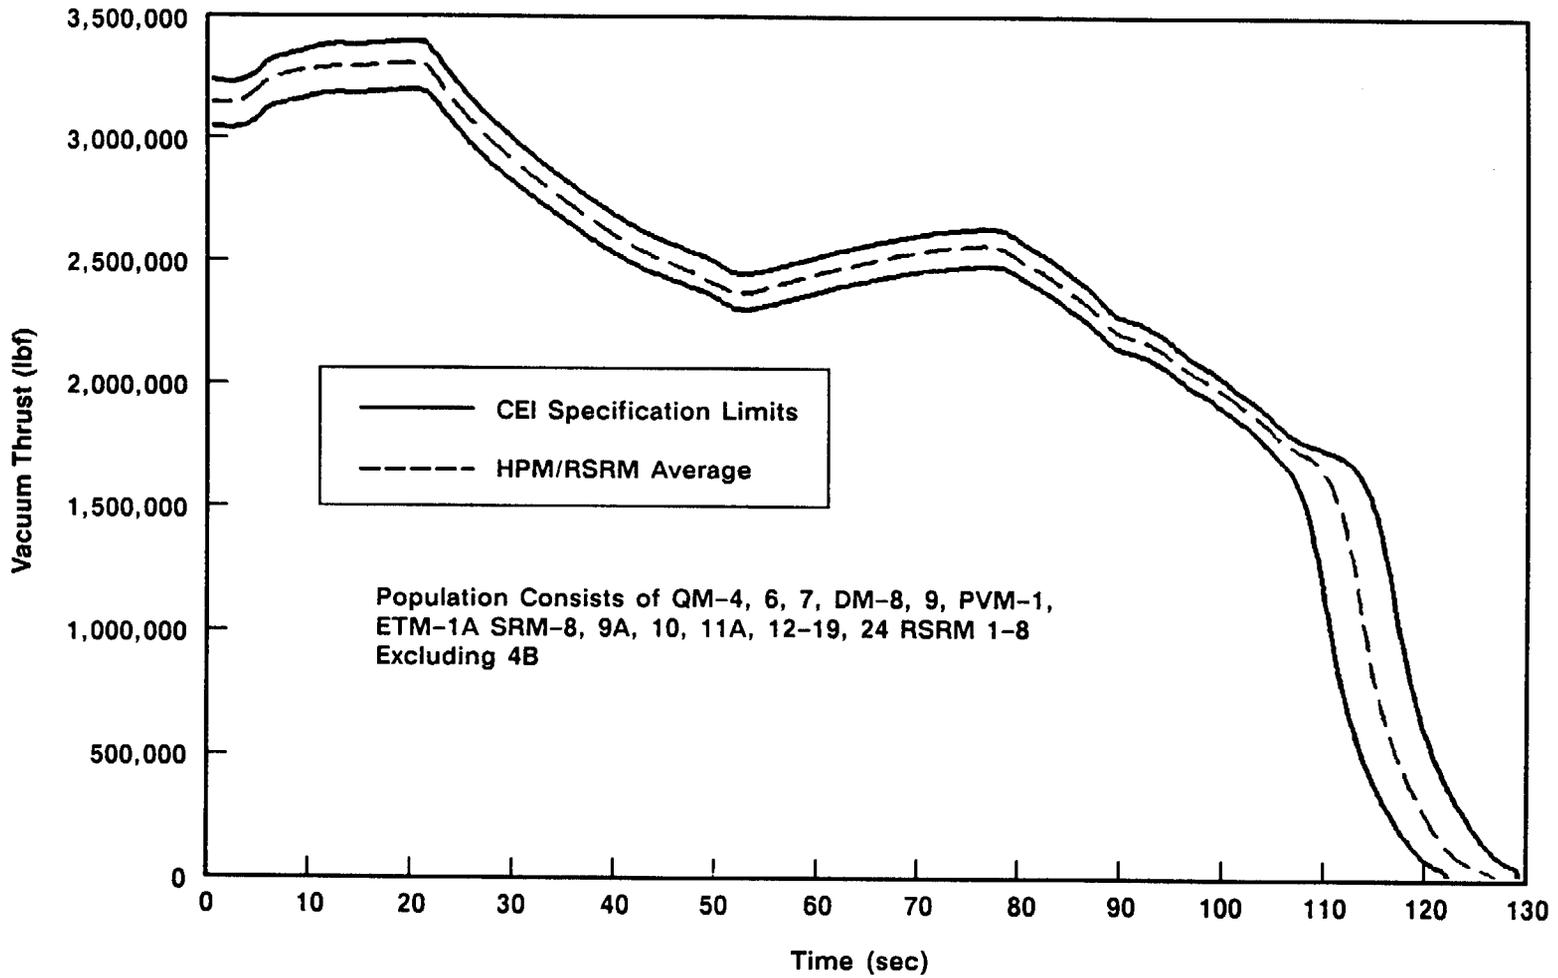
Figure 4.4-1. HPM/RSRM Average Thrust Versus CEI Specification Limits

<u>Objective</u>	<u>CEI Paragraph</u>	<u>Conclusions</u>
Certify that the thrust-time performance falls within the requirements of the nominal thrust-time curve.	3.2.1.1.2.1 (see Nominal Thrust-Time Curve)	Certified. The thrust time performance was within the nominal thrust-time curve (Figure 4.4-1).
